MINUTES

DEFENSE CONFERENCE ON NONDESTRUCTIVE TESTING

ANNUAL
MEETING

4, 5, 6 OCTOBER,
1966

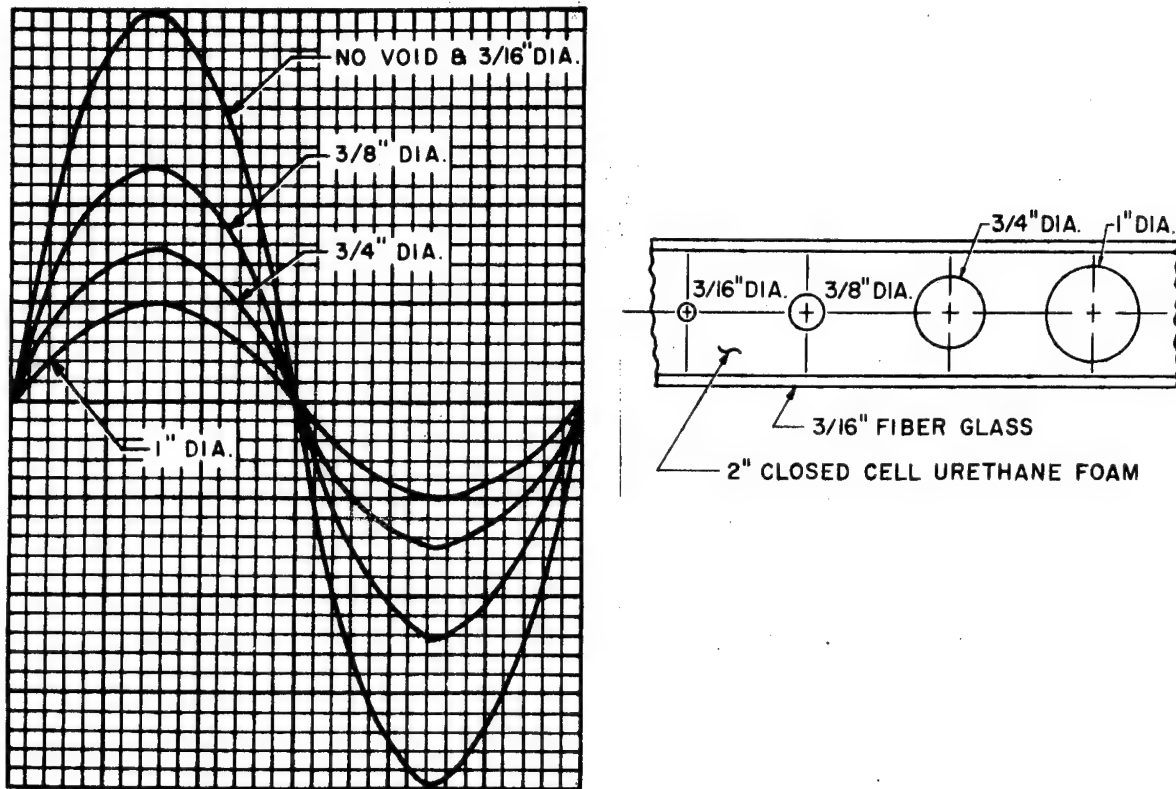
Figure 13. Attenuation Vs. Void Size

Figure 13 shows the location and size of various diameter holes in the urethane foam and the signal attenuation caused by these holes. From this

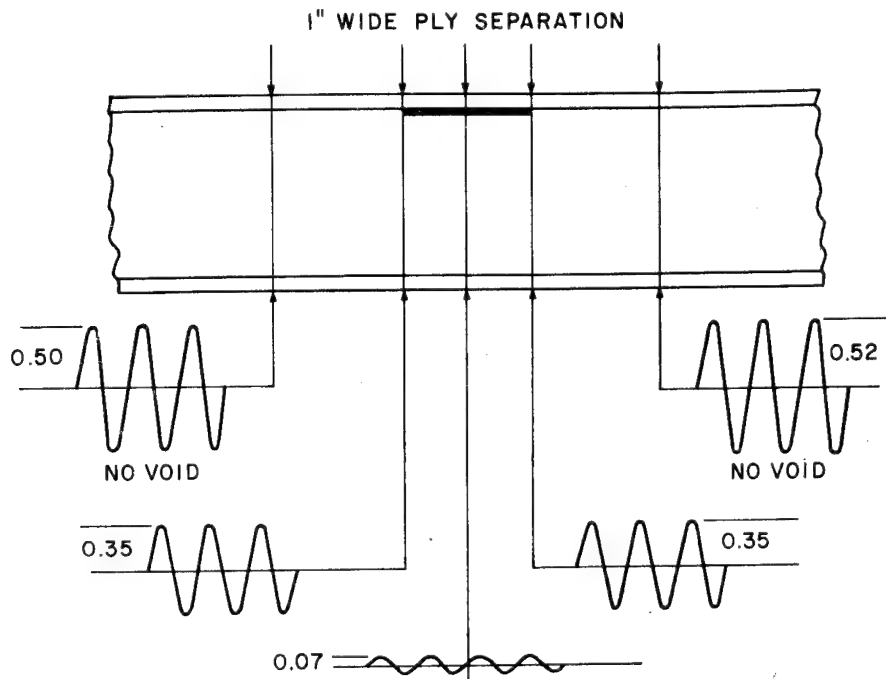
Figure 16. Attenuation Vs. Position of Transducer over 1" Wide Ply Separation

Figure 16 shows the effect of attenuation versus transducer location relative to the centerline of a 1 inch ply separation. Due to the closeness of the transducer to the defect the relative location of the transducer greatly effects attenuation.

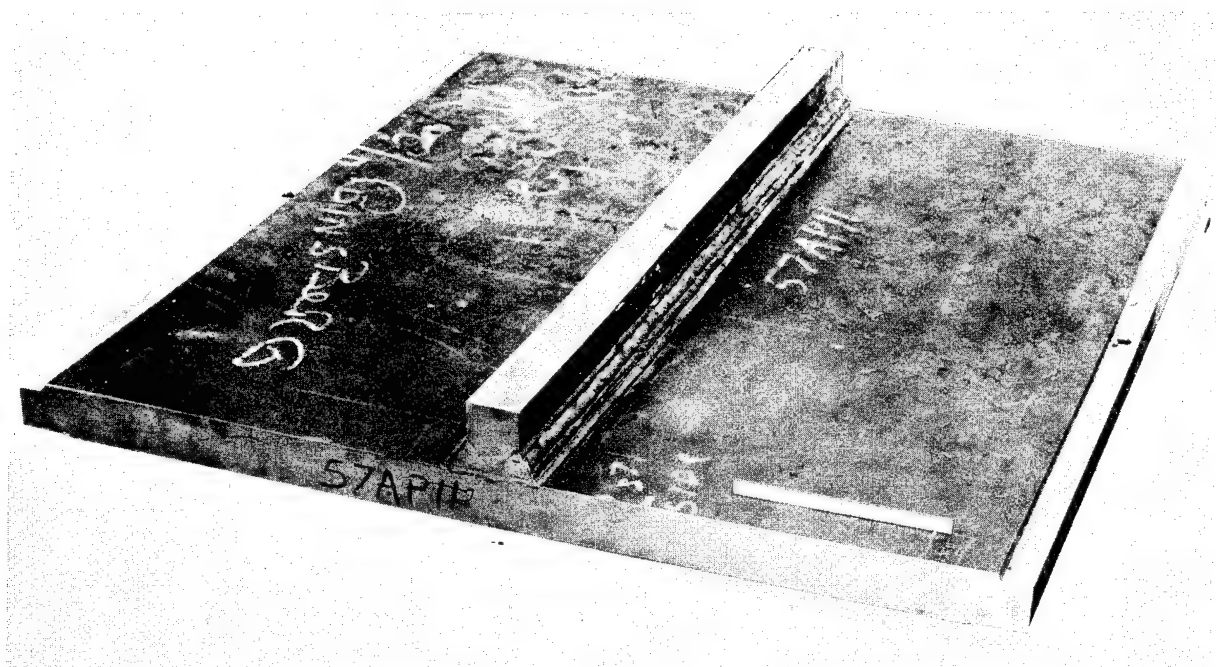
Figure 1. Tee-Welded Fatigue Specimen

The tee-welded plate fatigue specimen is shown in Figure 1. The test must be carried out without removing the specimen from the machine in which it is subjected to the cyclic loading. Figure 2a is an overall view of the experimental setup. The ultrasonic probe must be manipulated within the limitations imposed by the heavy grid structure of the holding down fixture which is over the specimen proper. A closeup of the specimen within the fatigue machine is shown in Figure 2b. Figure 3 shows a butt-weld plate specimen which is being developed for exploratory crack growth studies for high strength steels. The appearance of the crack at about 6X, on the rough polished specimen edge, is shown in the enlarged portion of Figure 3.

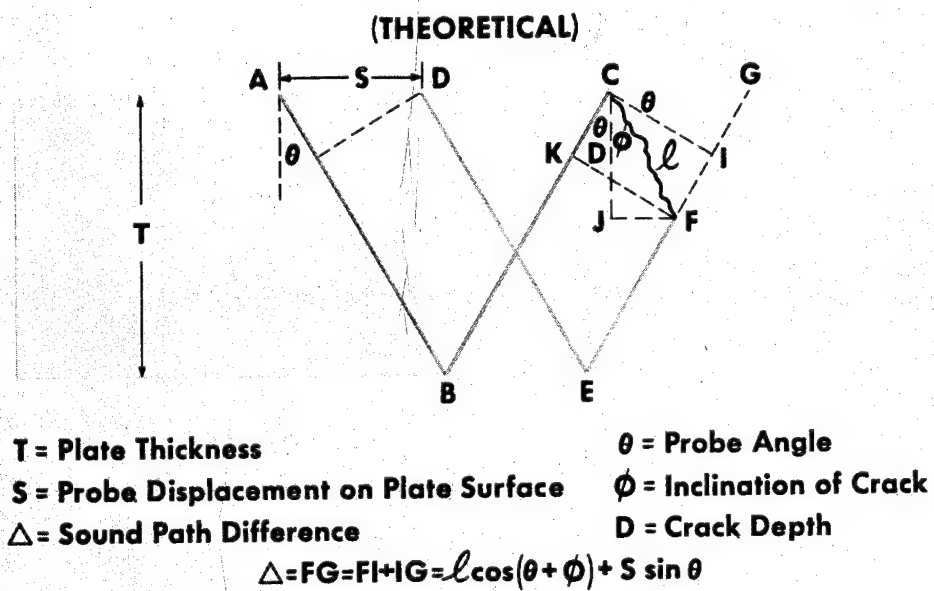
Figure 4. "Back-Reflection" Method

Analytical expressions for the inclination and depth of the crack for the tee-welded specimen were first derived by the use of a "back-reflection" method and on the simplifying assumption that the ultrasonic beam has no width. Figure 4 shows a sketch used to make the analysis. The vertical component of the crack depth, d , and its inclination to the vertical, \emptyset , are functions of two items which are measureable. These are:

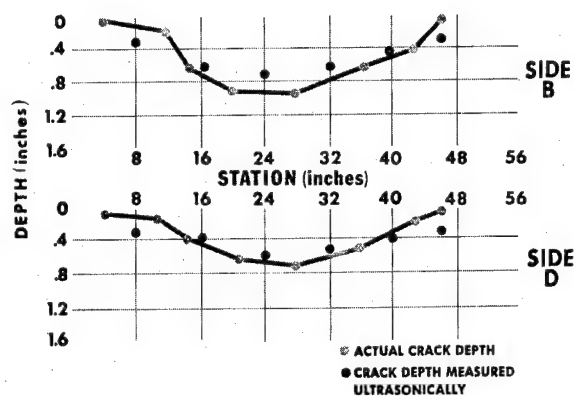
Figure 8. Initial Results for Tee-Welded Fatigue Specimen. Crack Depth for Various Stations, Actual vs. Ultrasonically determined

Figure 8 summarizes initial results obtained by the approach just described. It will be noted that the agreement for depths of about 1/2 in. and over is fair to good, based on visual observation of cracks at corresponding sections of the weldment. On the other hand for shallower depths the agreement between ultrasonically determined values and actual ones is poor and the former are consistently an overestimate. This difference can be explained by the fact that in actual practice the beam width is not zero.

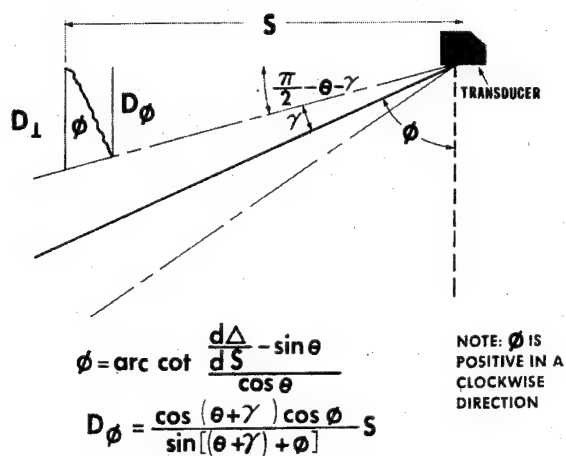
Figure 9. "Direct" Reflection Method

Figure 9 shows the transducer in position for which the extreme ray of the sound beam, having a finite angular width, just reflects from the bottom of the crack. The inclination of the crack can be determined from the equation

Now, if as in Figure 9, d_ϕ = vertical depth of the crack, and γ = half angular beam width, it can be shown that:

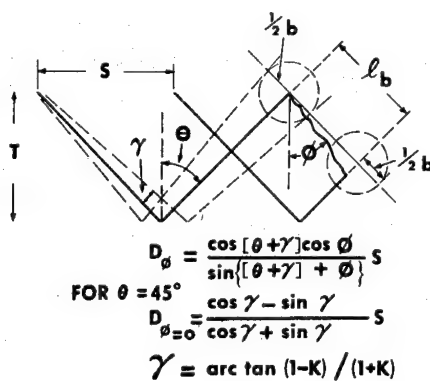
Figure 11. Effect of Beam Width on Crack Depth Estimation

Beam Width and Accuracy of Crack-Depth Estimate - In Figure 11, let l_b = expected length of crack in plane normal to the beam direction; then

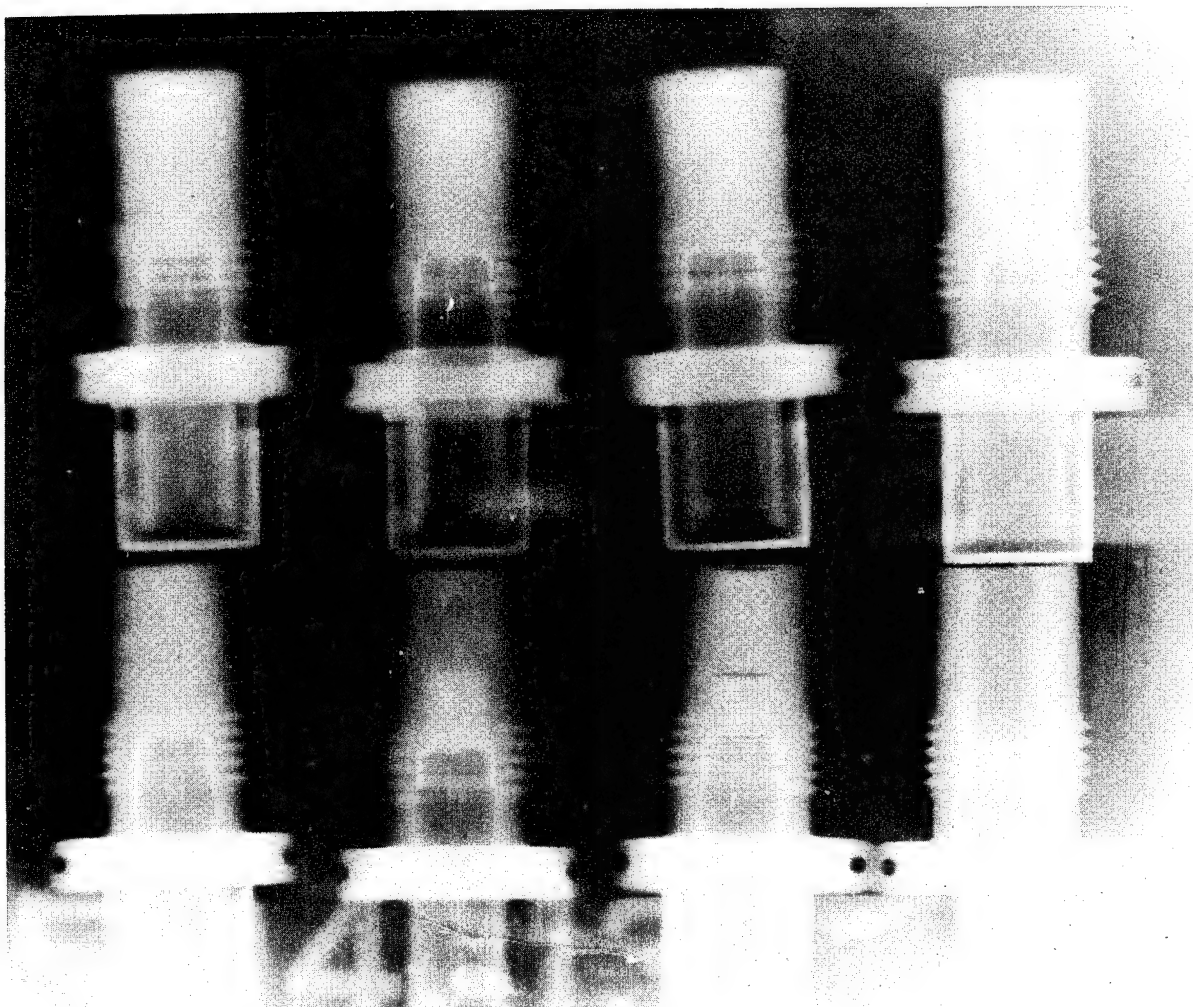
Figure 1. Neutron Radiograph of POLARIS EBW Detonators

Upper row and lower left detonators show no discontinuities;

14 - bottom row - contains remelted PETN in lower half and low density powder in upper half

lower right - empty

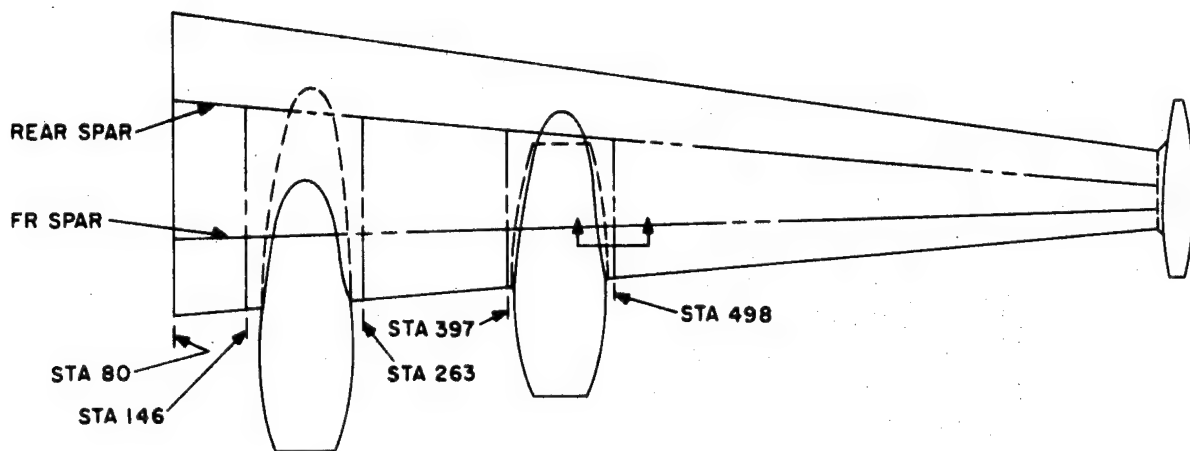
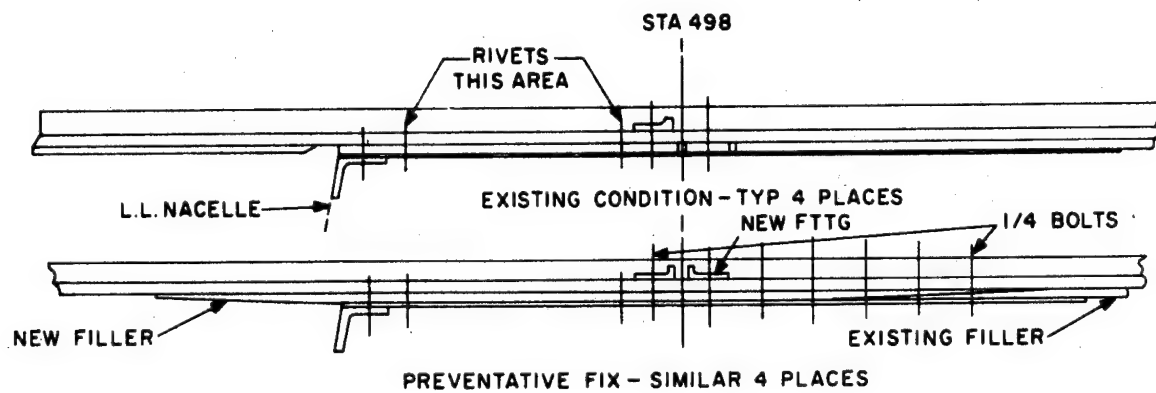
Figure 1.

REPAIR PROCEDURE PER DWG 5458547

1. REMOVE LEADING EDGE
2. REAM 1/4 BOLT HOLES TO .032 OVERSIZE
3. ADD FILLER & TAPER SPLICE TO EXISTING FILLER
4. REPLACE (1) FTTG WITH NEW FTTG TO NEST INSIDE FLANGE
5. REPLACE EXISTING RIVETS WITH 3/16 OVERSIZE SCREWS
